Public Disclosure Regarding Aitik Tailings Facility

2023-07-24

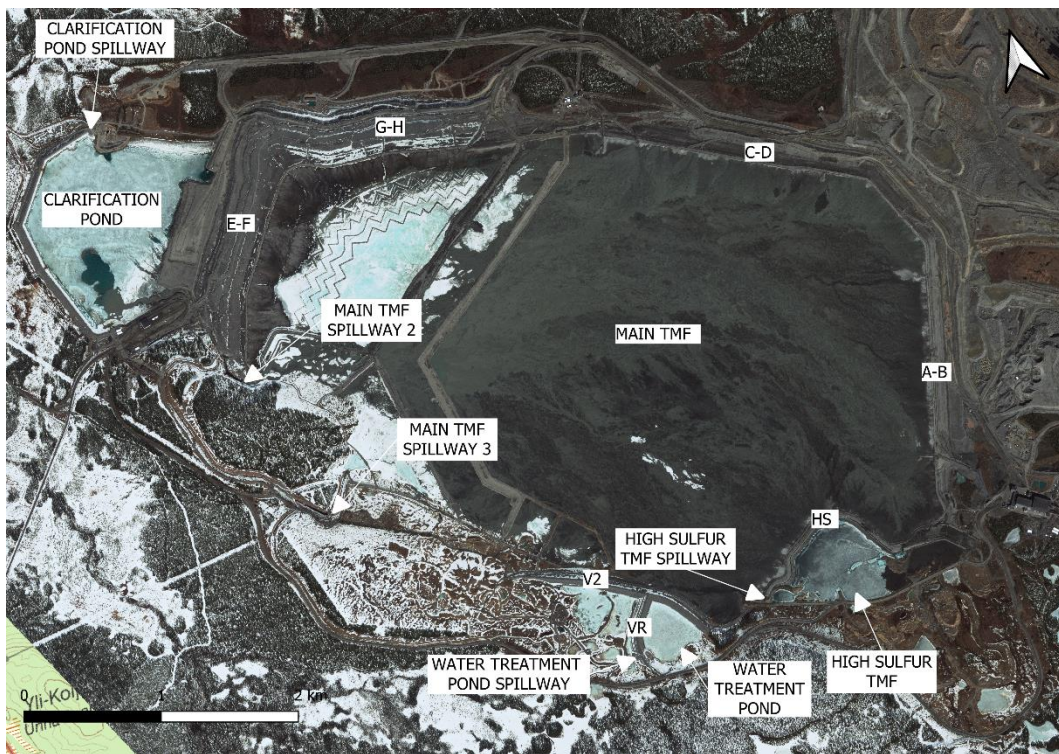
Figure 3 Aerial photo (May 2023) of the Aitik tailings facility

The tailings facility consists of the Main TMF, the High Sulfur TMF, the Water Treatment Pond and the Clarification Pond, see **Figure 3** for an aerial photo, and **Table 1** for a description of the main structures. For more information regarding the dams, see Chapter 5.
